Pre-Design Inspection Summary Report

Artistic Printing

Former Vermiculite Intermountain Facility-SLC2

Libby Sister Sites (Asbestos Project)

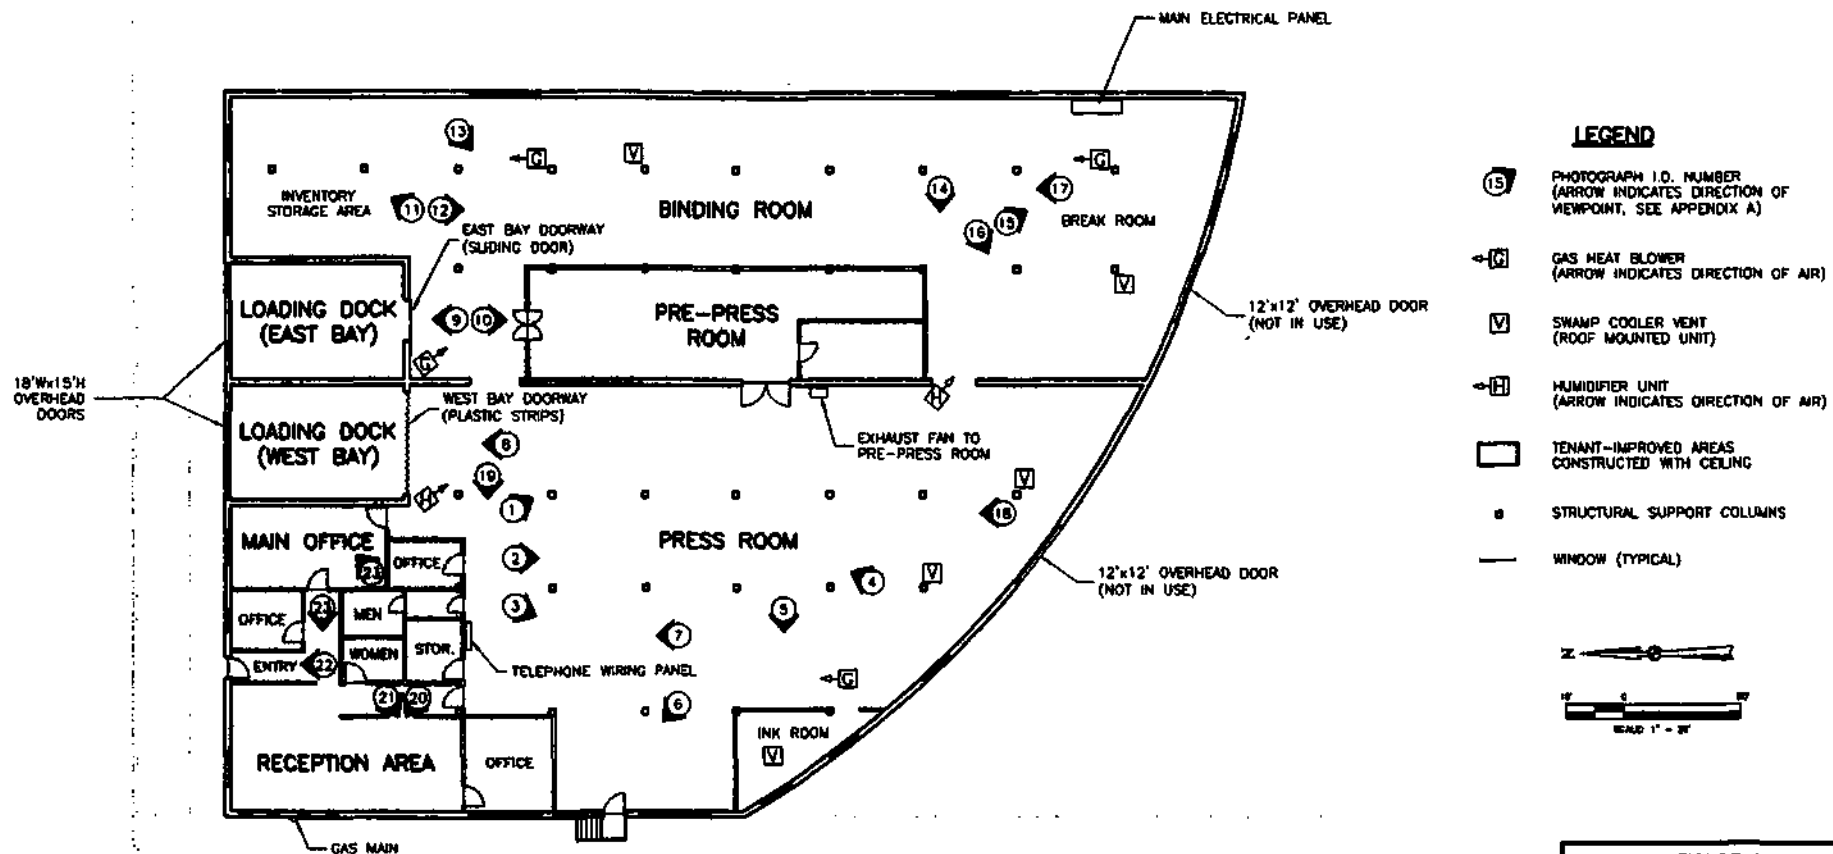
FIGURE 1

The building measures approximately 18,500 square feet (ft²) and is roughly the shape of a rectangle (Figure 1). However, the southern end of the building is in the shape of a rounded convex curve as it borders the location of a former railroad spur that served the former processing facility. It is a single-story building constructed of brick with painted slump stone masonry walls and a built up flat roof. The calibrating portion of the building does not have an attic area but does contain storage space above the pre-press room. It is estimated that the building contains approximately 27,750 ft² of horizontal surfaces to clean. This area includes the total floor space plus table/counter space, estimated at 50 percent of the total floor area.

The building is approximately 90 years old and is in relatively good shape. There do not appear to be any major structural concerns; however, there are a few miscellaneous cracks in both the interior and exterior walls, most likely due to settling.

The main entrance to the building is located along the northern wall, leading into the office area (Figure 1). Other building entrances include a proper doorway along the west wall, two loading dock doors along the north wall, and two unused bay doors along the southern wall. A chain link fence securing a large Utah Transit Authority (UTA) transformer has been erected approximately 2 feet (ft) from the southern end of the building. There are operable windows (historically opened) along most of the exterior walls. The interior walls are constructed of painted slump stone masonry. The floors are made of finished concrete. The ceiling is approximately 15 ft high with open joists.

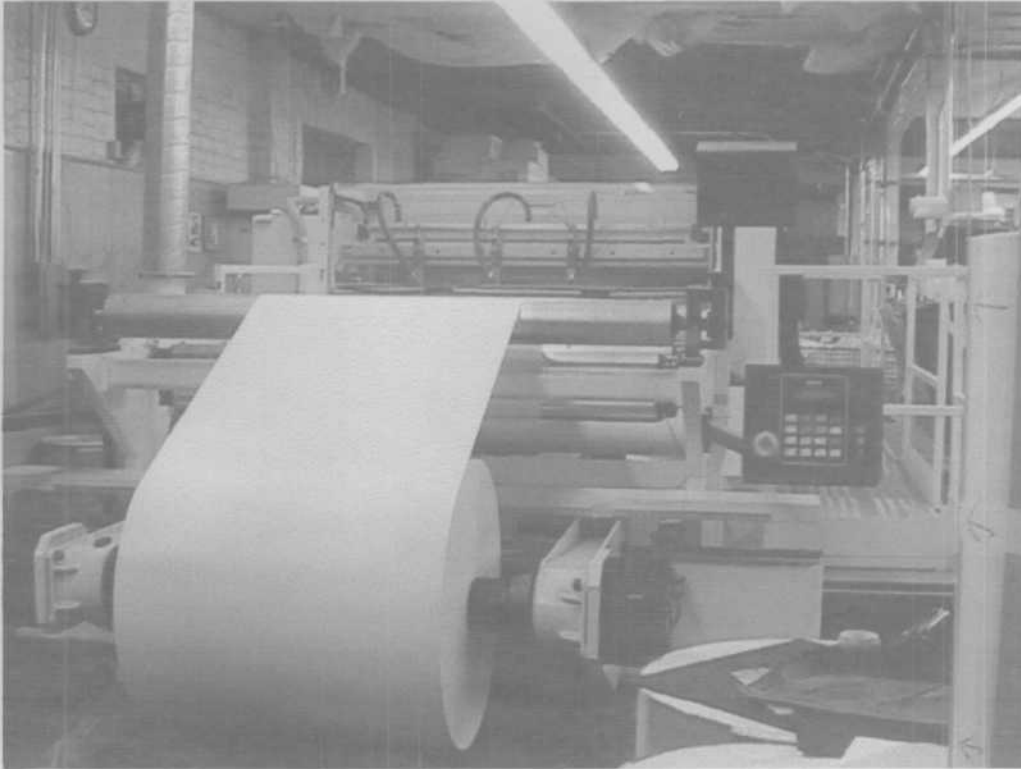
The press room contains three main pieces of printing equipment (Attachment A, photographs 1 through 4). These consist of a sheeter, six-color printing press, and a two-color printing press. Mr. Benson expressed concern for protection of the two printing presses during the removal operations. Specifically, he was concerned that debris and/or dust would be introduced to some of the printing press intricacies during cleanup and clearance activities. He suggested that the two printing presses be covered with poly sheeting before aggressive cleaning activities are conducted. The printing press machines are large and encompass most of the room. There are several control units and electrical conduits throughout. As part of the printing operation, corn starch is applied at various stages of the printing process. Because of this, there is a corn starch residue throughout most of the press room, especially around the perimeter of and underneath the printing presses. Effective cleaning methods for the printing presses may include vacuuming the machines with a backpack vacuum equipped with a high efficiency particulate air (HEPA) filter.

The business owner previously affixed poly sheeting to the ceiling for purposes of preventing particulate matter from falling into sensitive printing equipment during roof repair several years ago. The poly sheeting no longer has a useful purpose and can be removed during cleaning activities.

1. Automatic sheeter in press room (looking south). Note poly cover on ceiling.

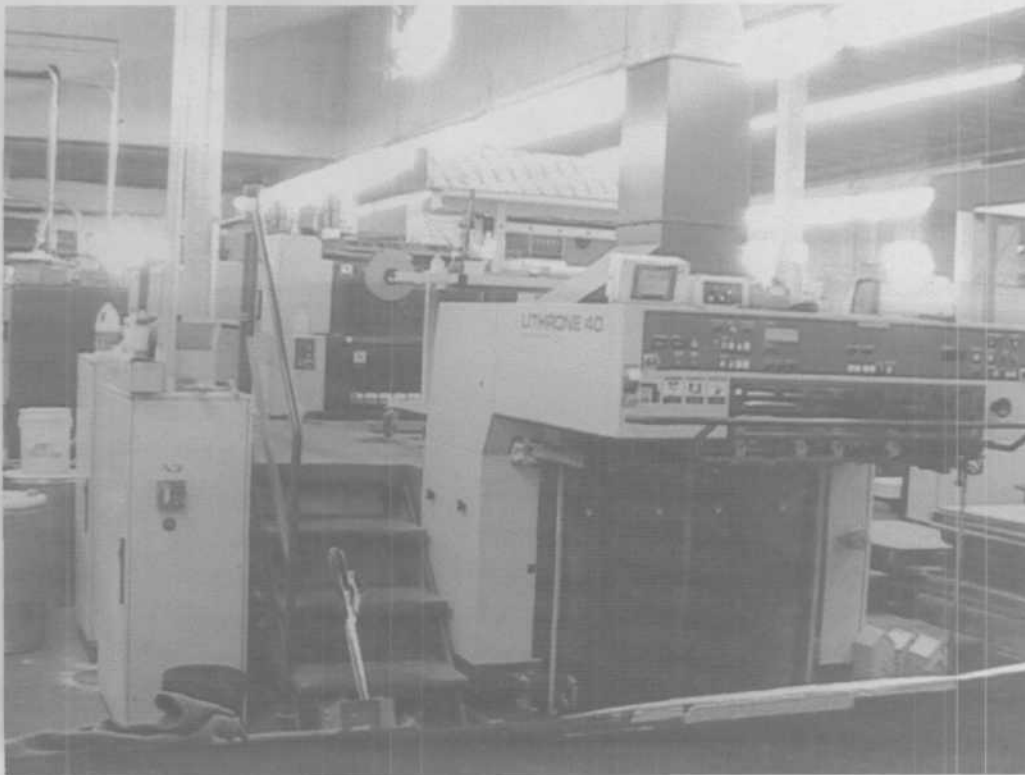
2. Six-color printing press in press room (looking south).

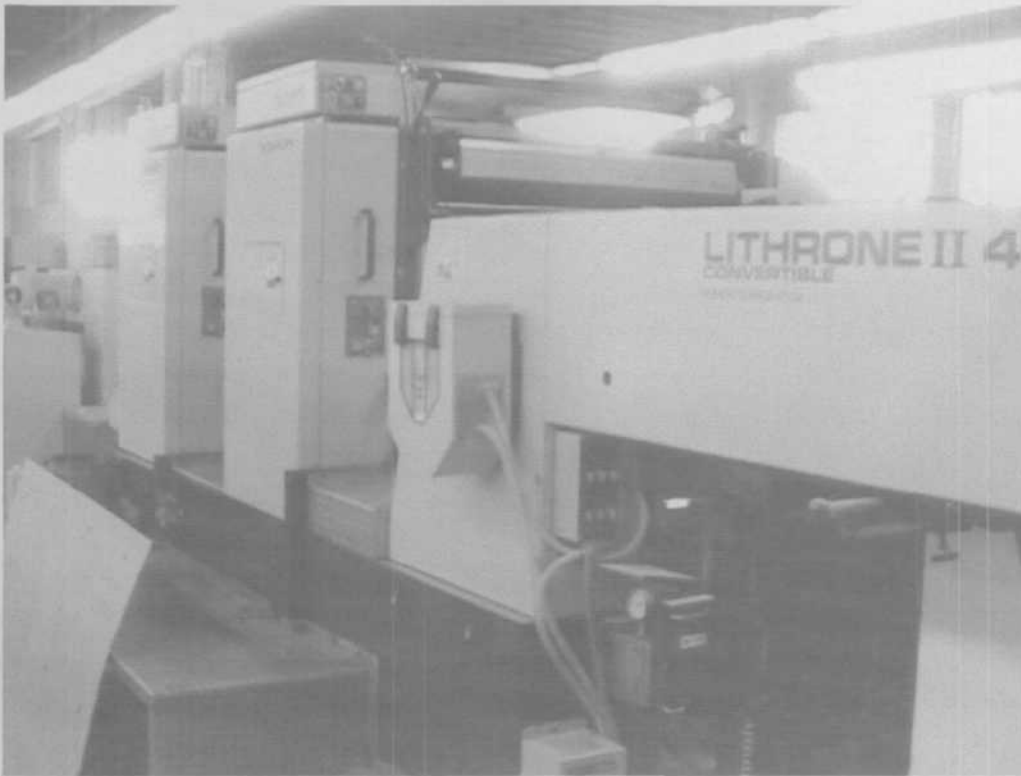
3. Two-color printing press in press room (looking southwest).

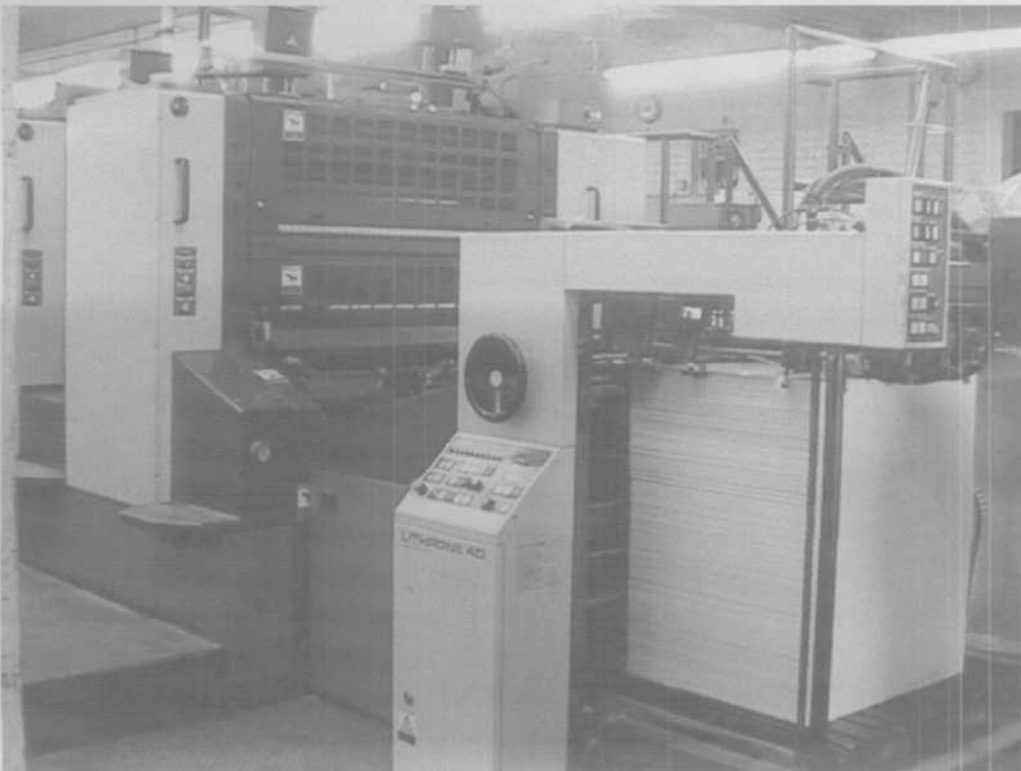
4. Six-color printing press in press room (looking northeast).

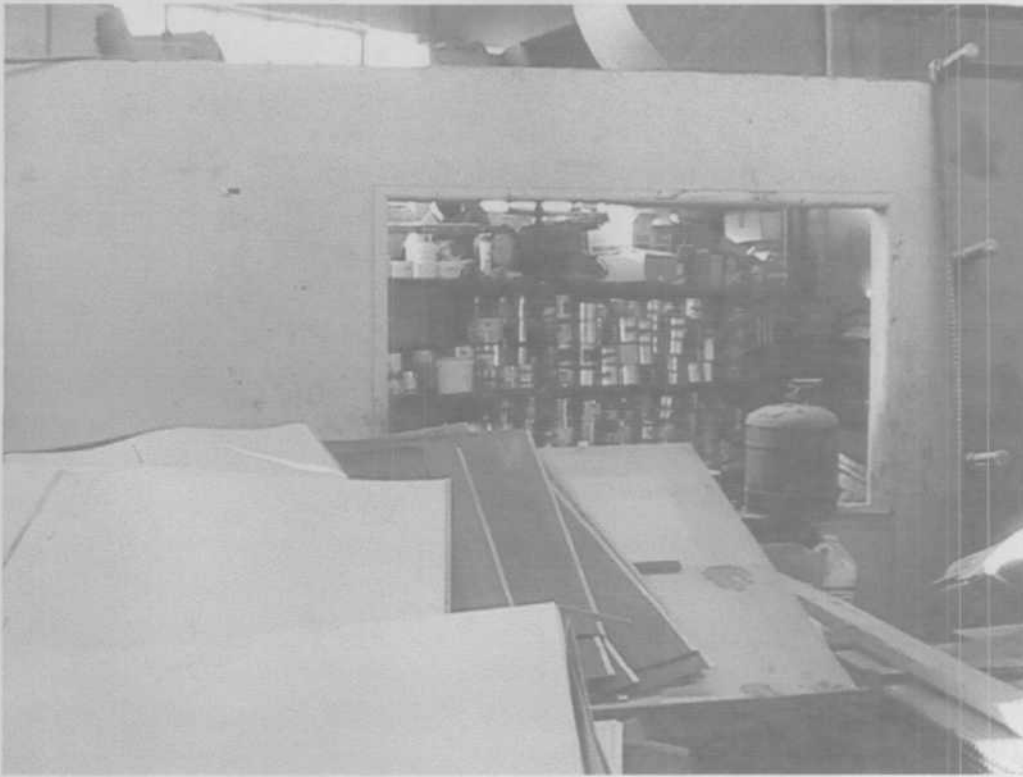
The ink room, located in the southwestern section of the press room, consists of an open air (i.e., no ceiling) room, measuring approximately 430 ft², sectioned off by a 10 ft high wood frame partition (Attachment A, photograph 5). The ink room is stocked with various sizes of cans of paint, solvents, and ink. It should be noted that some of the aforementioned products may be considered hazardous waste (for disposal purposes). Also within the ink room, there are miscellaneous tools (i.e., nuts, bolts, hoses, etc.) and work benches.

5. Ink room (looking west).

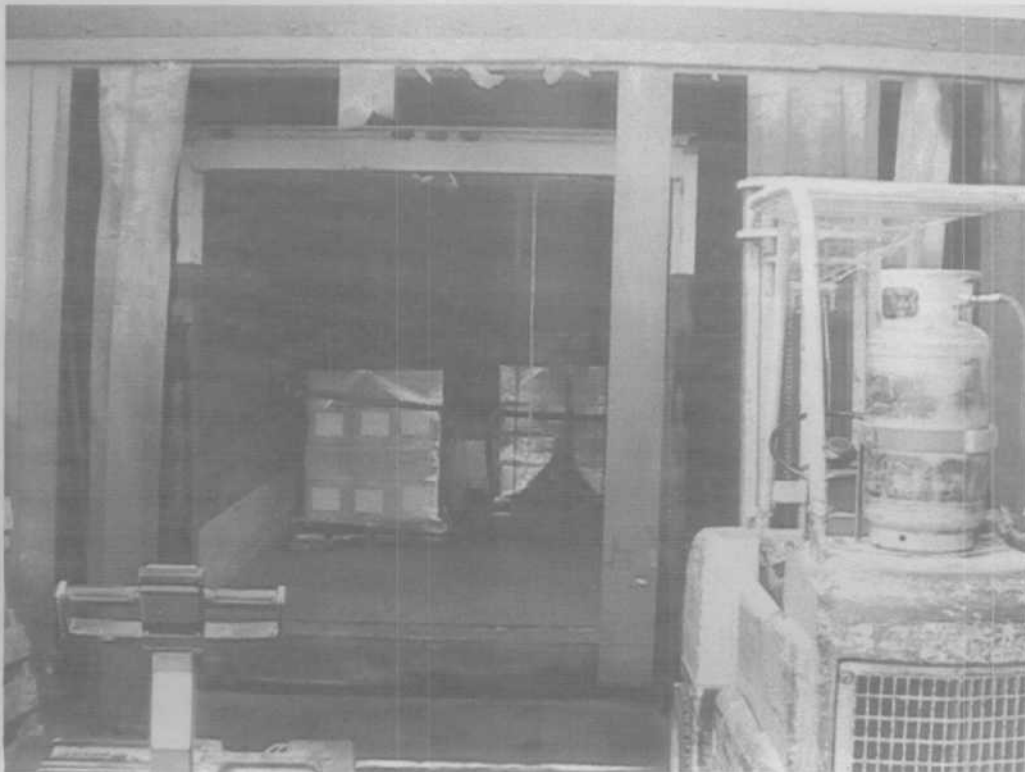
The loading dock is located on the north end of the press room and east of the office area (Figure 1). There is a 17.5 x 10 ft open entrance (no door) to the loading dock. There are vertical plastic strips separating the loading dock from the press room (missing some strips). The loading dock external entrance consists of a large 18 x 15 ft rollup bay door. The loading dock is used primarily for shipping and receiving inventory for the printing operation. There is no significant inventory stored in the loading dock.

8. West bay loading dock (looking north). Note vertical plastic strips.

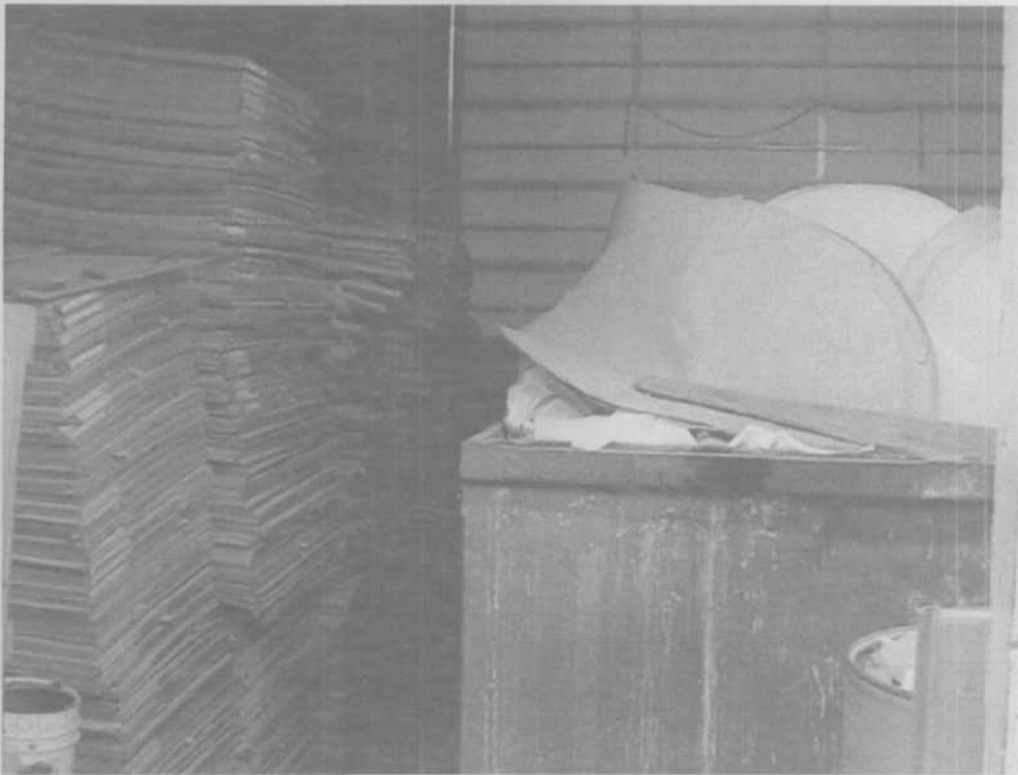
There is a storage area in the northern section of the binding room (Attachment A, photograph 11). This is where the main inventory for the printing operation is stored. Another loading dock is directly west of the storage area. There is a 7 x 5 ft door along the southern wall of the loading dock. The loading dock external entrance consists of a roughly 8 x 10 ft sliding bay door. This loading dock is primarily used to store film negatives, an antique car, delivery truck, and miscellaneous files (Attachment A, photograph 9). In addition, the room is used to store the main trash receptacle (dumpster).

9. East bay loading dock (looking north). Note the stacks of negatives in case along west wall.

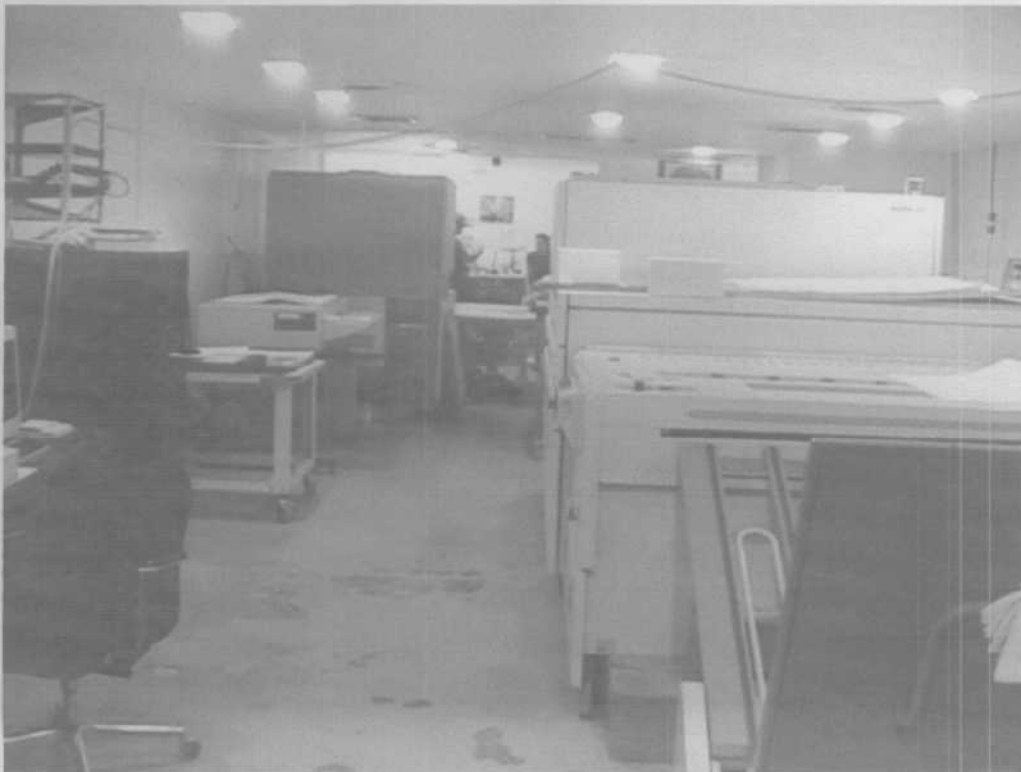
The walls and ceiling of the pre-press room consist of painted sheetrock and the floor is finished concrete (Attachment A, photograph 10). There is a separate room in the southern end of the pre-press room that serves as a black room (film development). There are two entrances to the pre-press room. These consist of two swinging doors along the north wall, leading to the binding room and a proper doorway in the western wall, leading to the press room. There are no windows within the pre-press room.

There are several personal computers, a server, and a computer-to-plate laser printer that takes up the majority of the room. The black room has a sink, benches, and other film developing equipment. Mr. Benson requested that the cleanup contractor be extremely careful when cleaning the pre-press room.

10. Pre-press room contents (looking south).

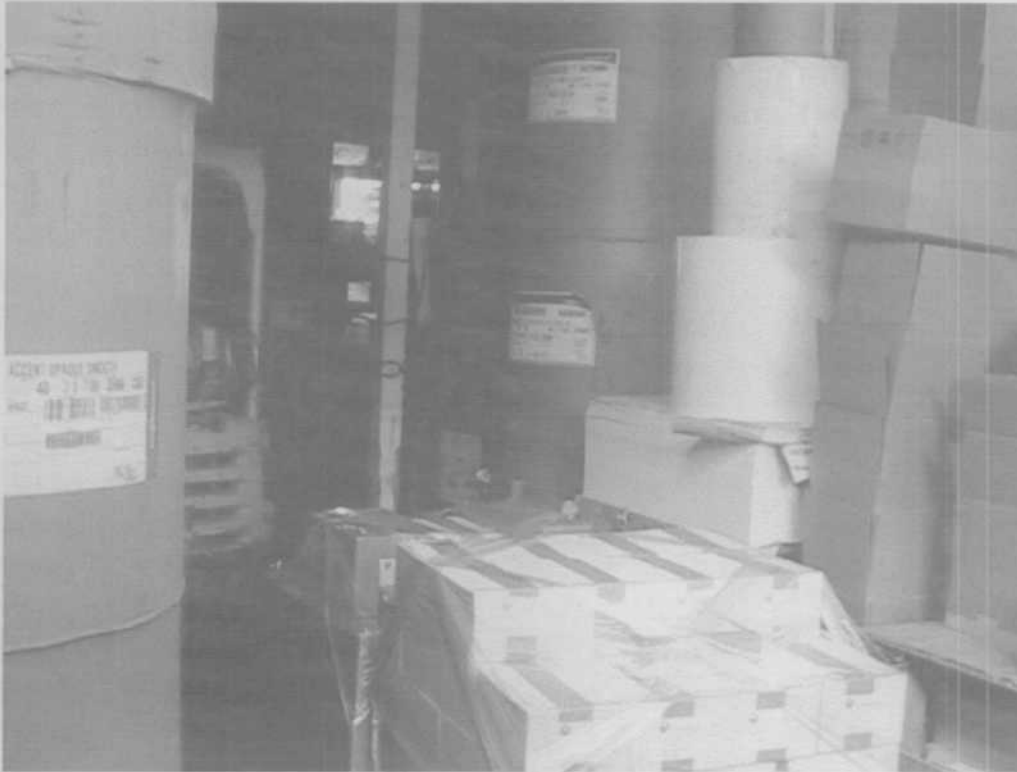
11. Storage area in northeast corner of binding room (looking northeast). Note inventory of paper and boxes of miscellaneous supplies.

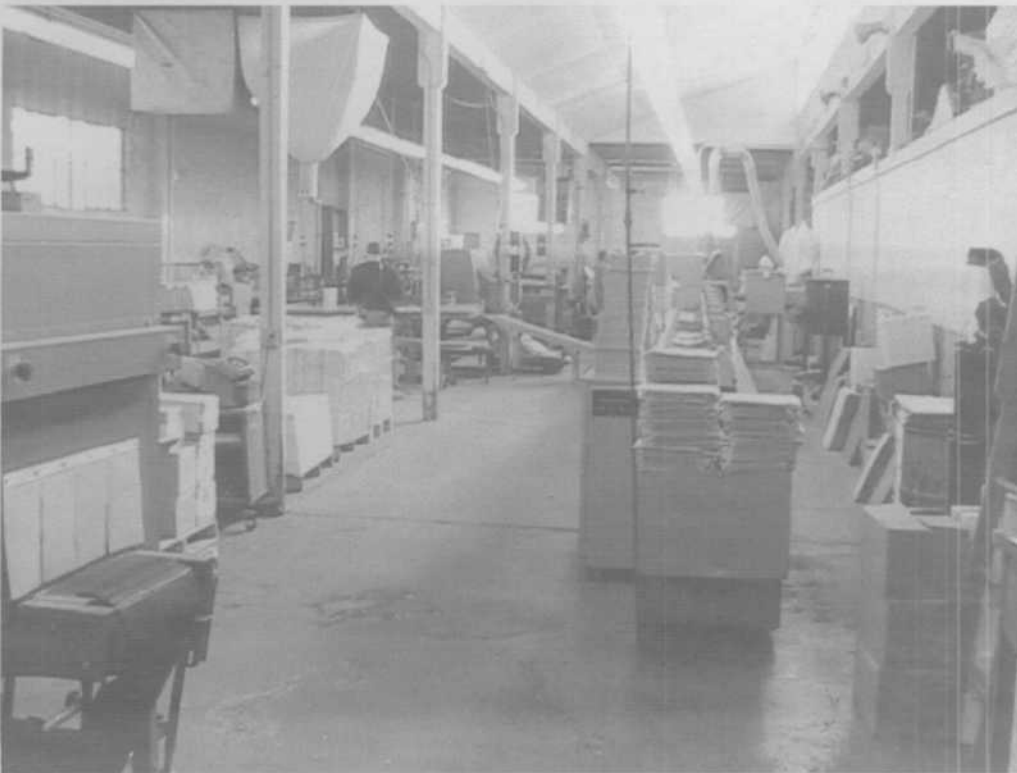
The finishing equipment includes an automatic folder, binder, collator, shrink wrap oven, and a cropping machine (Attachment A, photographs 12, 16, and 17). In addition, there are sheets and rolls of paper stored in the binding room. The employee break area is located in the southeastern section of the binding room. There are no walls separating the break area which includes a folding table, chairs, microwave, and a soft drink machine.

12. Binding room contents (looking south). Note pre-press room on right side of picture and pitch in roof.

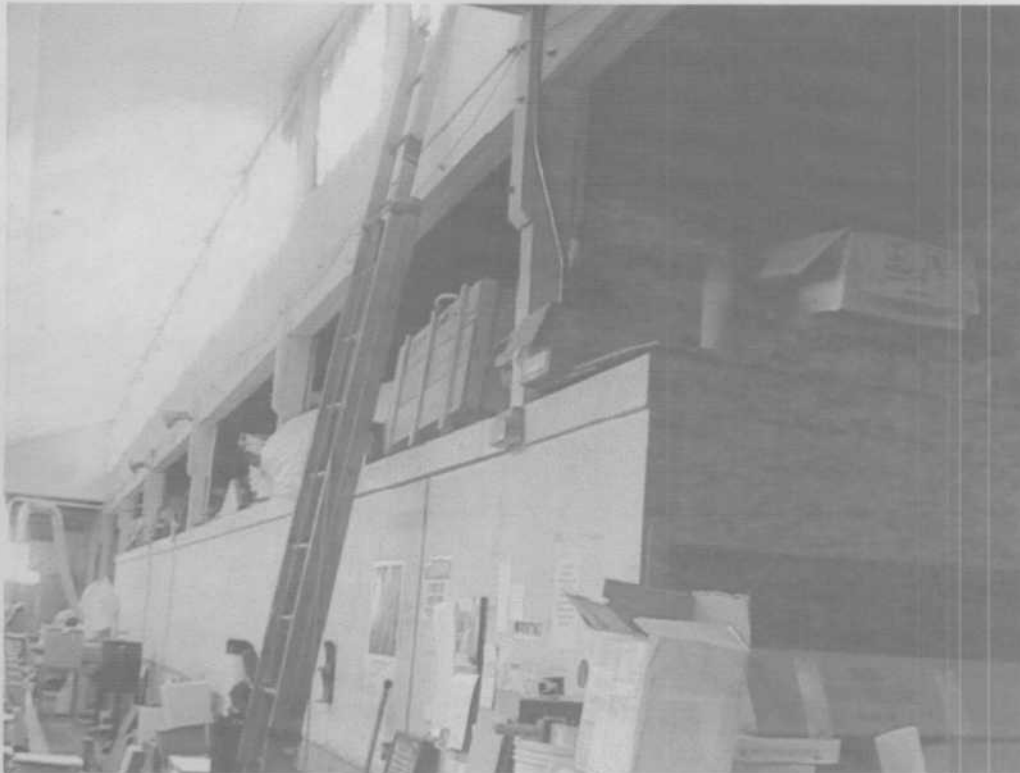
13. Exterior walls of pre-press room (looking southwest). Note items stored on roof of the pre-press room.

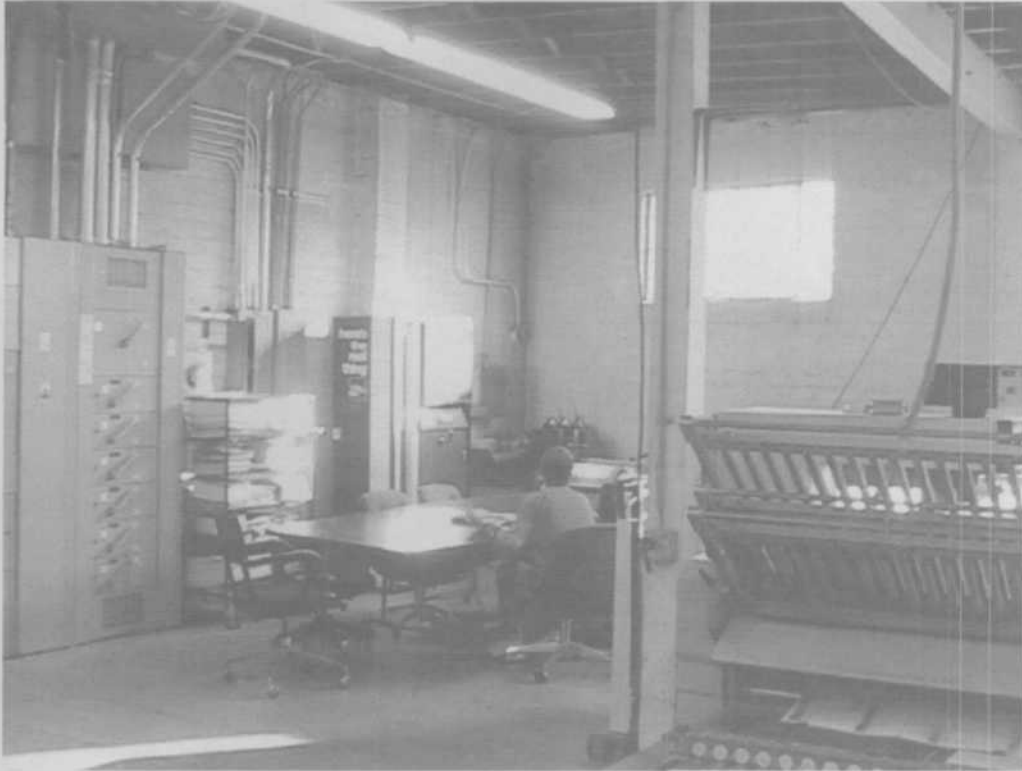
The primary electrical power shutoff box is located on the eastern wall of the binding room (Figure 1). There are several electrical wire conduits that service the office area and printing equipment in the press room. Water sources are located throughout the building.

15. Break area in southeast corner of binding room (looking southeast). Note main electrical panel along the east wall.

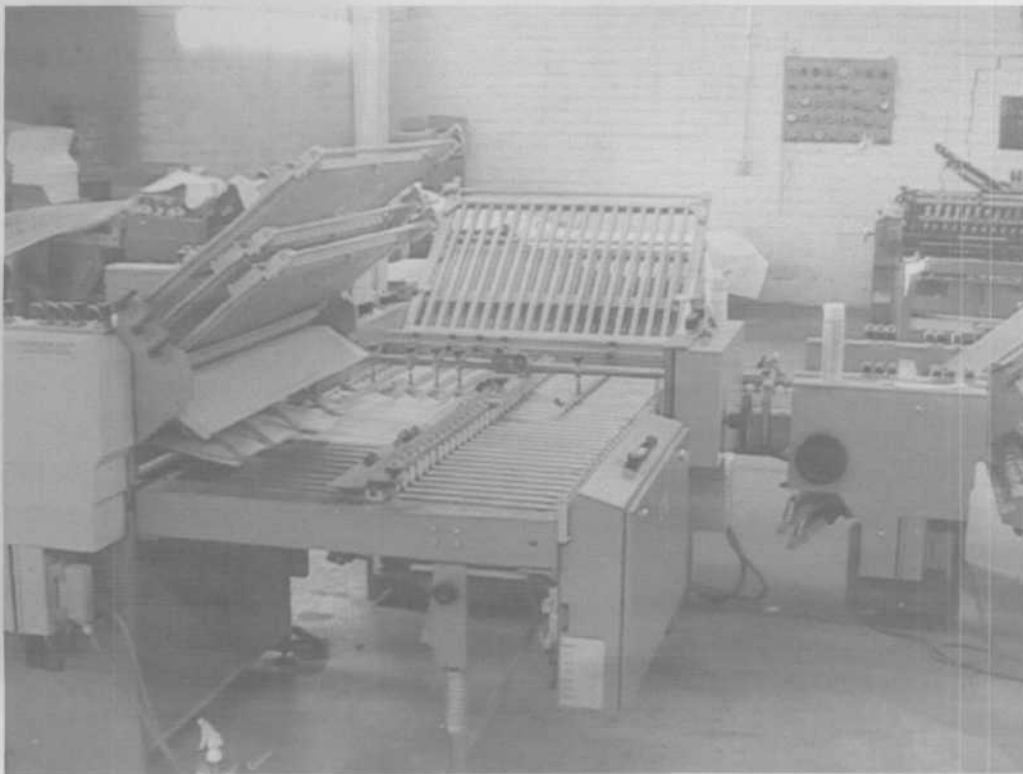
16. Automatic folding machine in southern portion of the binding room (looking west).

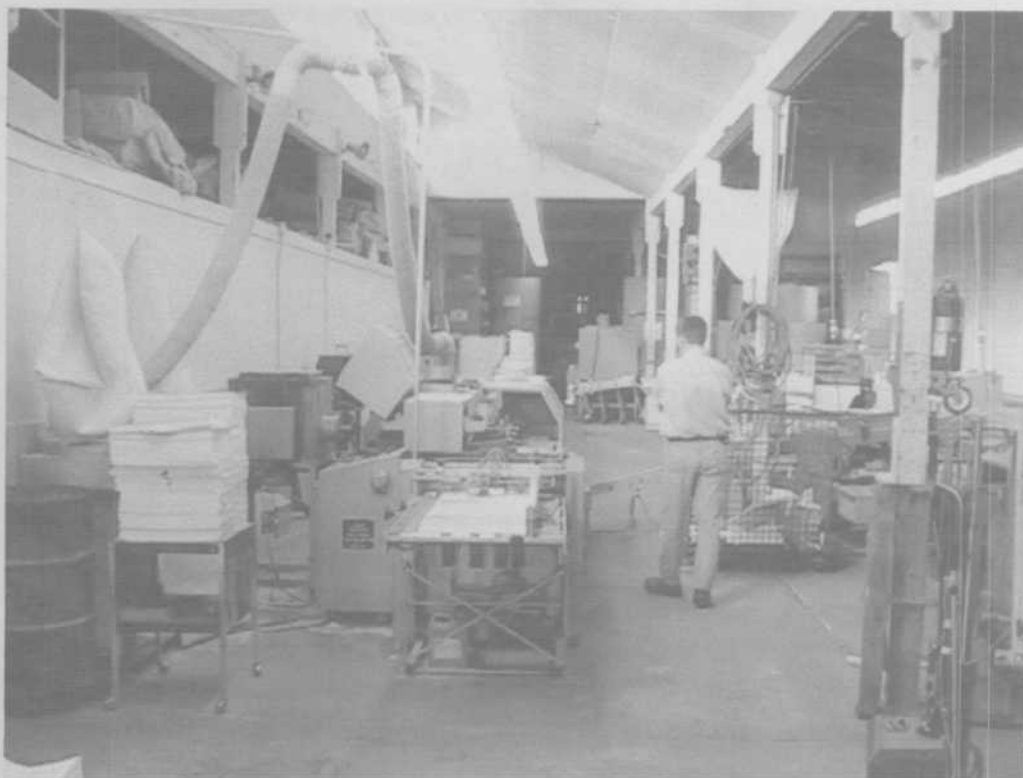
17. Binding room contents (looking north).
